Group Commander Kevin O'Neill

Community Development Dept

Harrow Court, Stevenage February 2005

Shirley Towers, Southampton, April

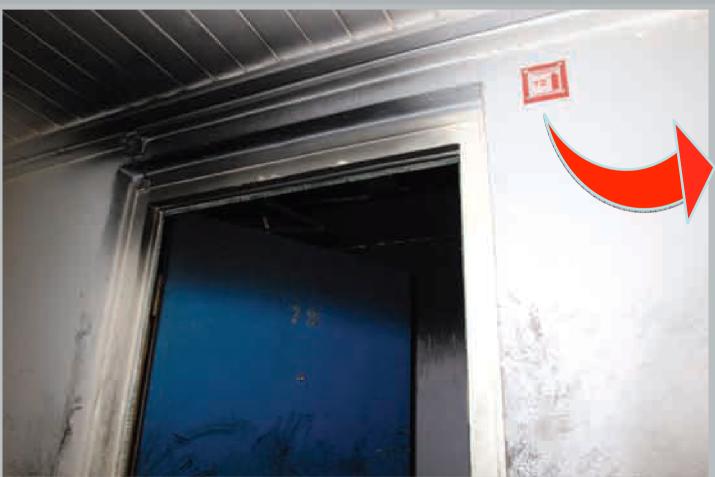
Post incident photograph of flat sign denoting (by arrow) that Flat 72 is an 'up' flat. Note the relatively minor smoke damage (Source: Hampshire Constabulary)

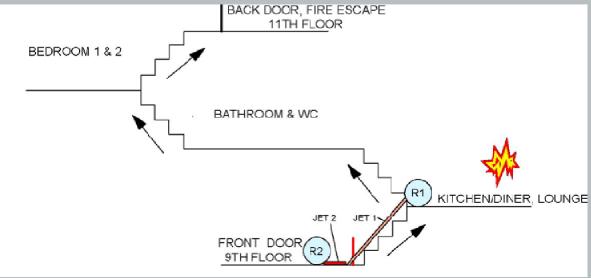
Plan of Flat 72, Shirley Towers.

Note:
Access to
lobby is on
the ninth
floor with
the fire exit
emergency
door
exiting on
the
eleventh
floor.

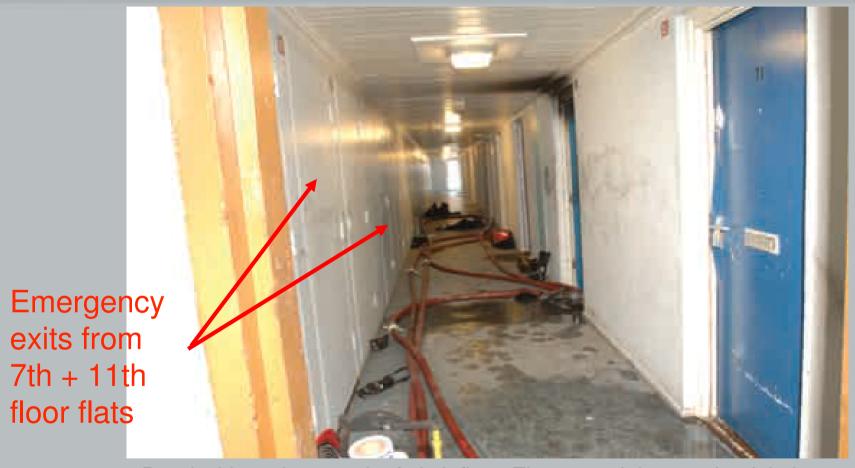
Post incident photograph of ninth floor. The second door on the right is the entrance to Flat 72. The white panel doors on the left are the fire escape doors to other flats. Note the relatively minor smoke damage. (Source: Hampshire Constabulary)

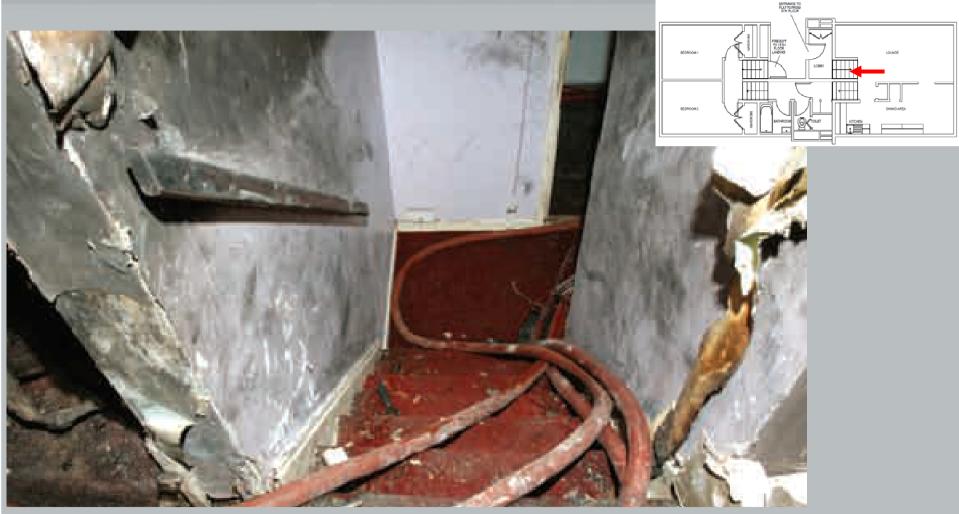
Post incident photograph from lounge level down stairs to entrance lobby. (Source: Hampshire Constabulary)

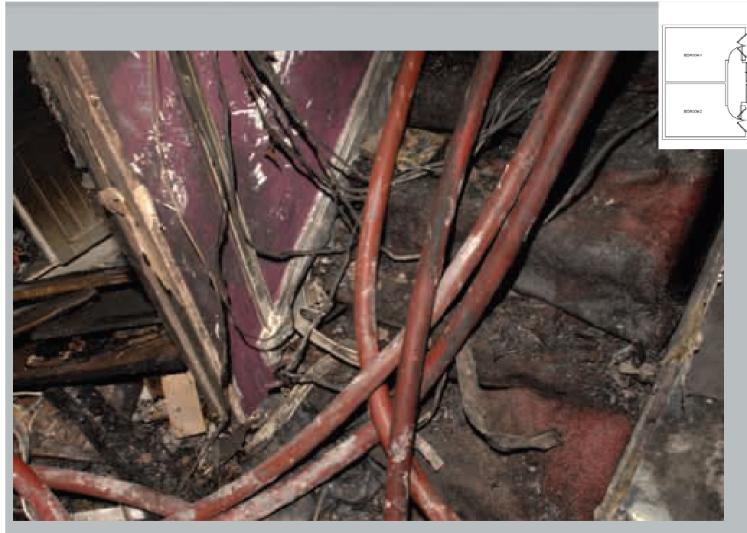
Post Incident photograph from lounge up stairs towards bathroom level. Note entrance to kitchen on left. (Source: Hampshire Constabulary)

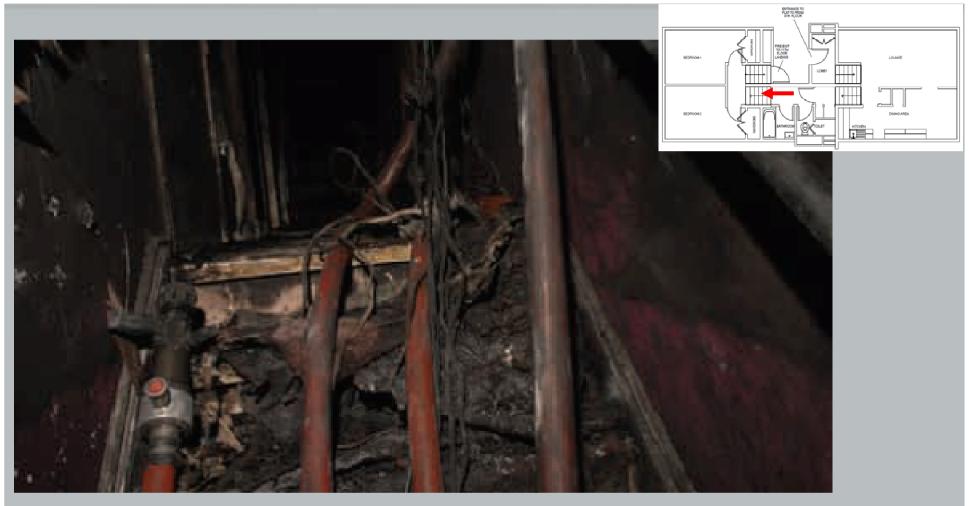
Post incident photograph looking up stairs from lounge window towards bathroom level. (Source: Hampshire Constabulary)

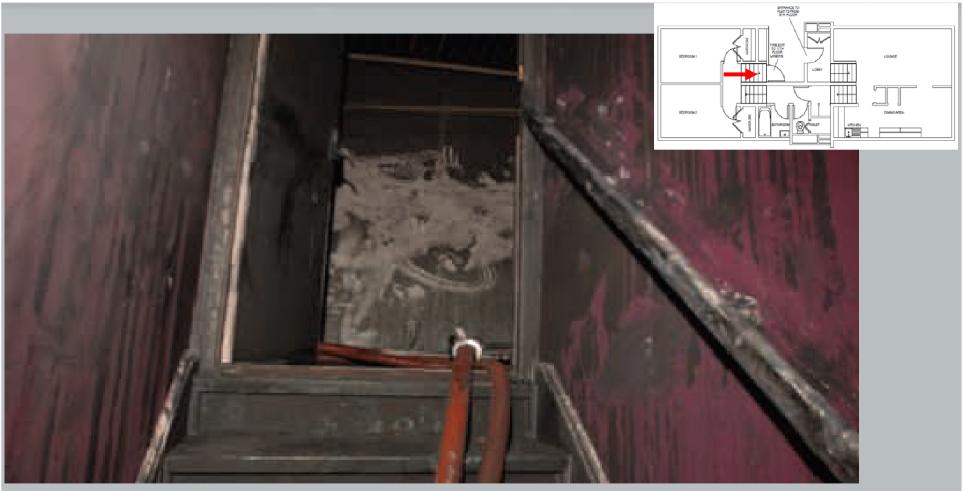
Post incident photograph up fire escape stairs from bedroom level towards eleventh floor fire escape door (open). (Source: Hampshire Constabulary)

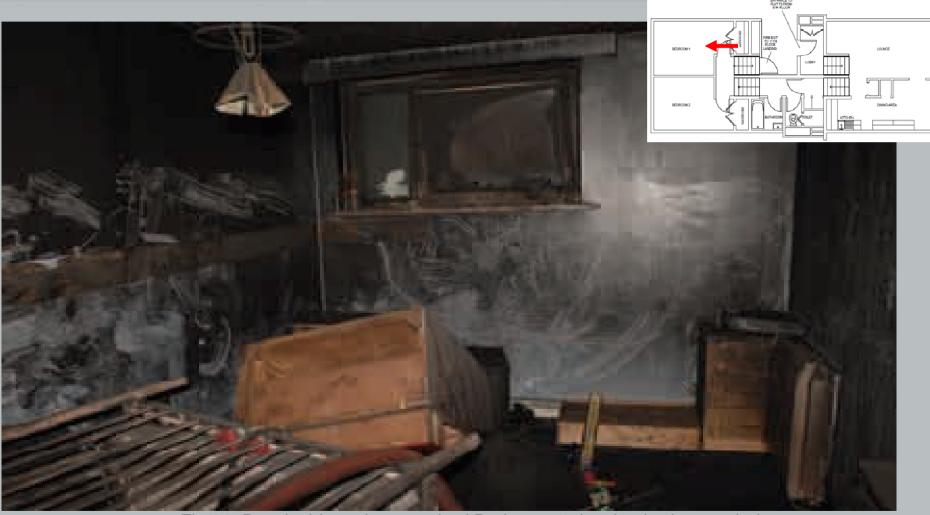
Fig 20: Post incident photograph of Bedroom 1 showing bedroom window (Source: Hampshire Constabulary)

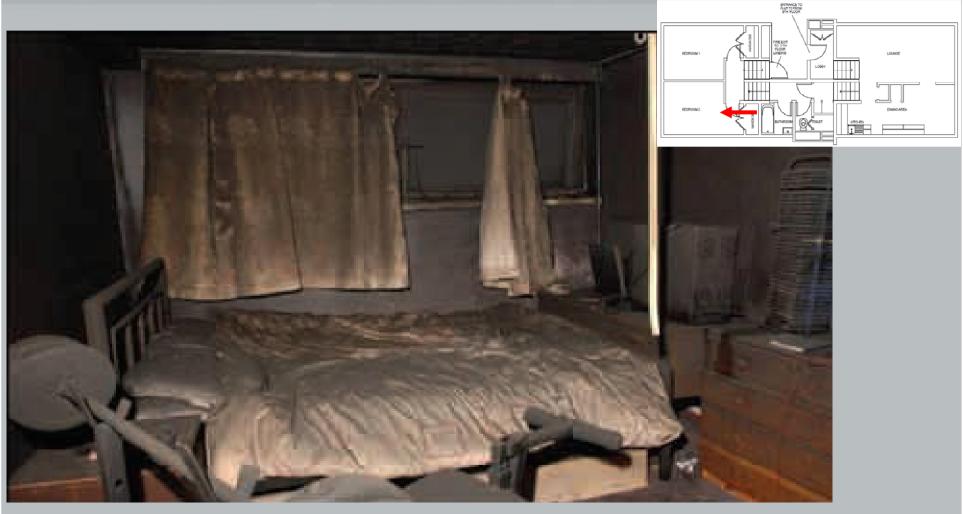
Post incident photograph of Bedroom 2 showing bedroom window (Source: Hampshire Constabulary)

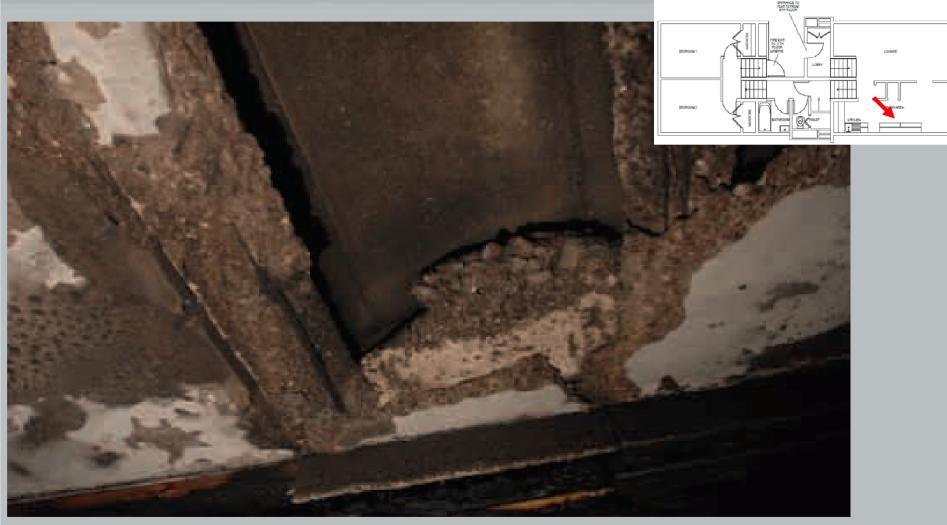
Post incident photograph of kitchen ceiling showing the fire damage to the concrete beams (Source: Hampshire Constabulary)

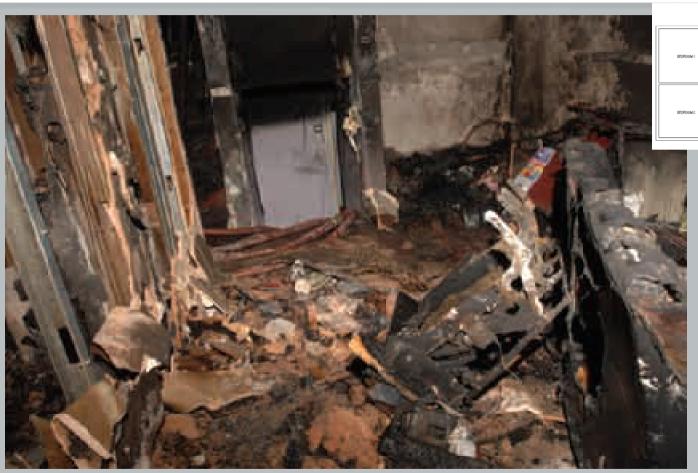
Post incident photograph of lounge from the window back towards staircase from entrance (middle) and the stairs leading up to the bedrooms (left hand side). (Source: Hampshire Constabulary)

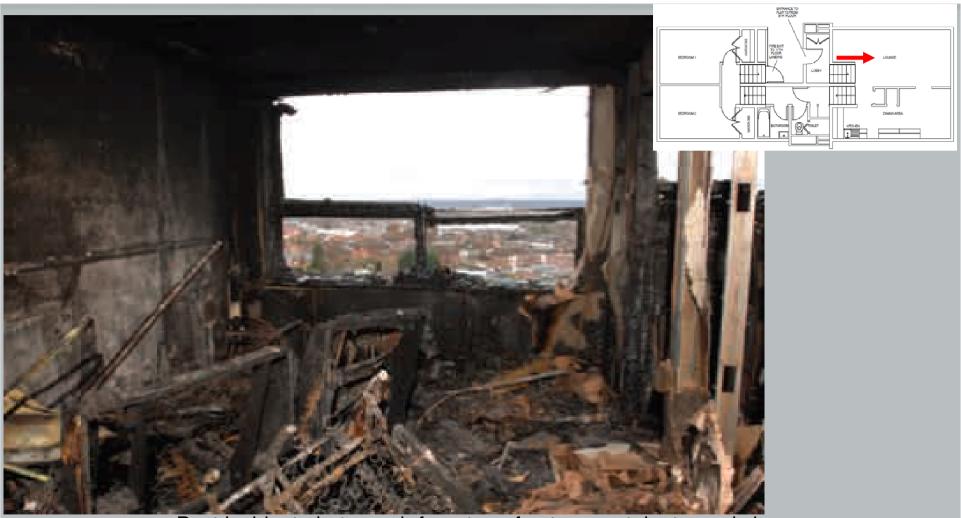
Post incident photograph from top of entrance stairs towards lounge window. (Source: Hampshire Constabulary)

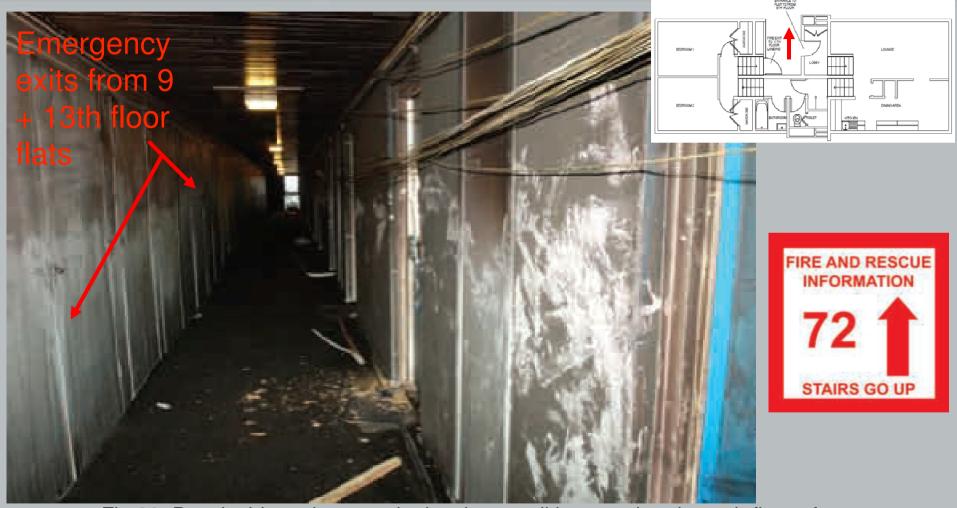
Fig 30: Post incident photograph showing conditions on the eleventh floor after the escape door from Flat 72 was left open. Note the displaced cables.

1.Remove all surface mounted plastic trunking/conduit used to protect and support the Fire Alarm and Automatic Fire Detection System in the Common Areas of all their premises, and replace them with a method of cable support which as a minimum conforms to BS 5839- Part 1 : 2002; clause 26.2 (f:)

2.It is recommended that Building Regulations are amended to ensure that all cables, not just fire alarm cables, are supported by fire-resistant cable supports. This could be achieved by an amendment to BS 7671 (2008) Institute of Electrical Engineers Wiring Regulations.

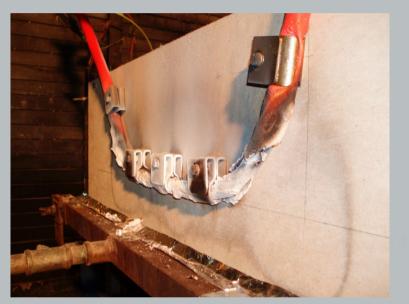
Cable supports conforming with BS 5839-1:2002; clause 26.2 (f:)

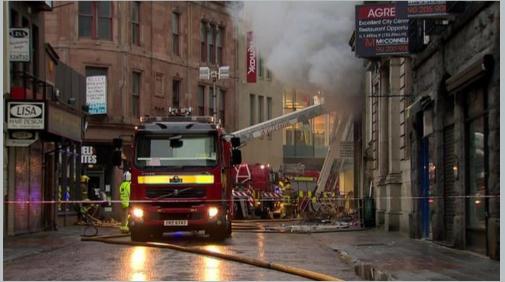
The fire extensively damaged the B&M Bargains shop in Rosemary Street
