The Obel Tower has been used as a case study due to a fire, which occurred there on 13 May 2013.

The Obel Building

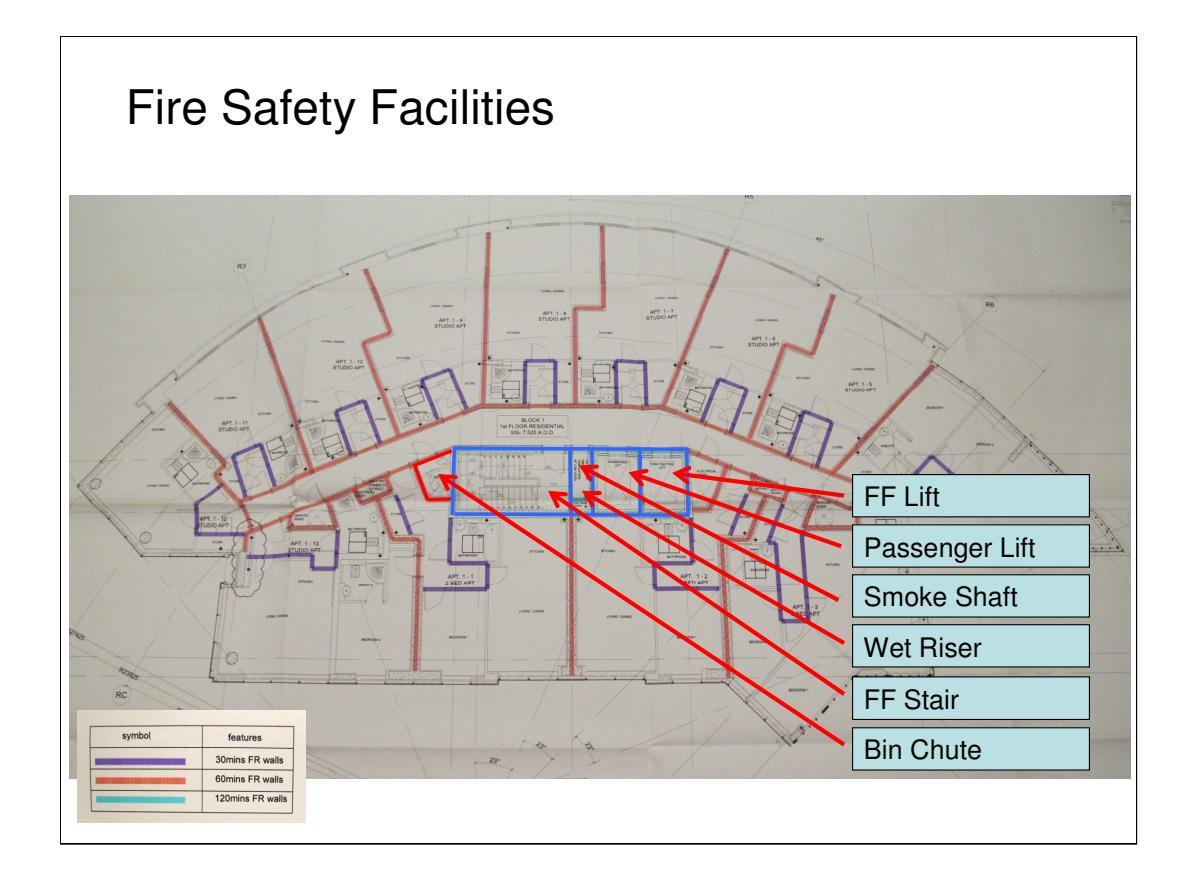
1. FF Lift

2. Passenger Lift

3. Smoke Shaft - opened by AFD on the Fire Floor, NIFRS Procedures is to set into riser 2 floors below. As a result NIFRS requested an over ride facility.

4. Wet Riser

Not built in accordance with the proposed Fire Strategy

Discovered by NIFRS on commissioning in July 2010.

Deviation from Technical Bulletin E, BS 5588 Part 5, BS5306 Part 1 (in place in 2004, both now replaced by: BS9999 Section 6 and BS9990:2006)

TBE E - The fire main should be located in the firefighting lobbies of the firefighting shaft.

BS 5306 Part 1 (or as it is now BS9990:200) - requires the riser to be provided with landing valves sited in a stair, ventilated lobby or any other position agreed with the fire authority

Lobbies to basement levels only.

5. FF Stair

6. Bin Chute

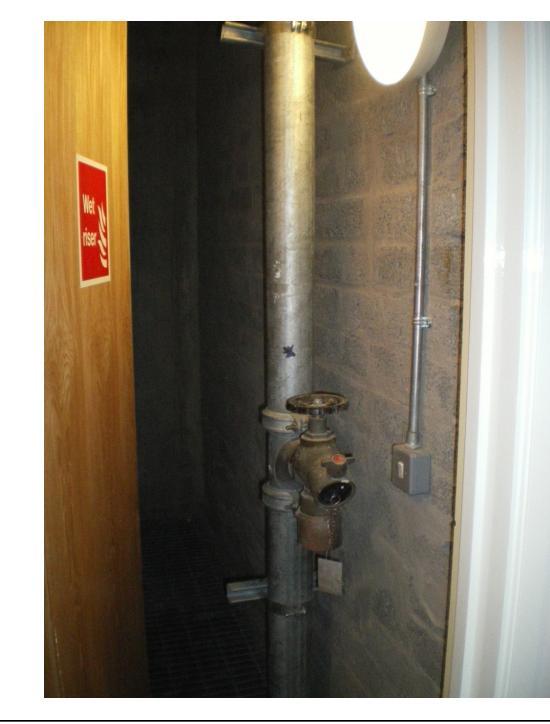
Problem 2 - Smoke Control Doors Fail

- supposed to open automatically on detection of smoke in corridor on fire floor
- this is also the door to the wet riser
- did not open
- corridors filling with smoke across all affected floors
- no handle on doors
- manual override on ground floor did not work
- Firefighters could not get
 water

Doors had to be forced to access the wet riser on floors 9, then 8 and 7 to secure water supplies

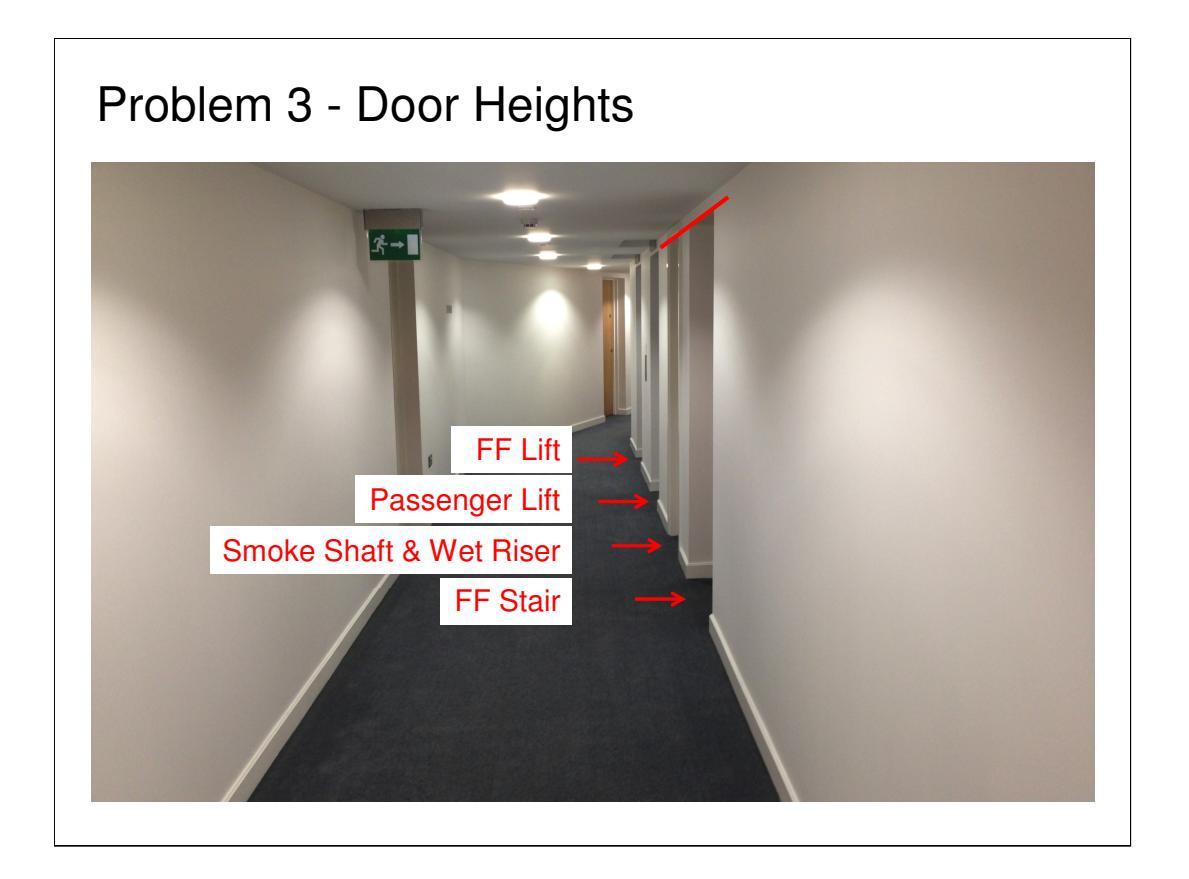
Next Slide: Door Heights

Top of smoke control door at same level as door to firefighting stair

Therefore smoke in a corridor will enter the firefighting stair and the smoke shaft

Firefighters bring hose up from stair below and into fire floor corridor, therefore both doors must be opened

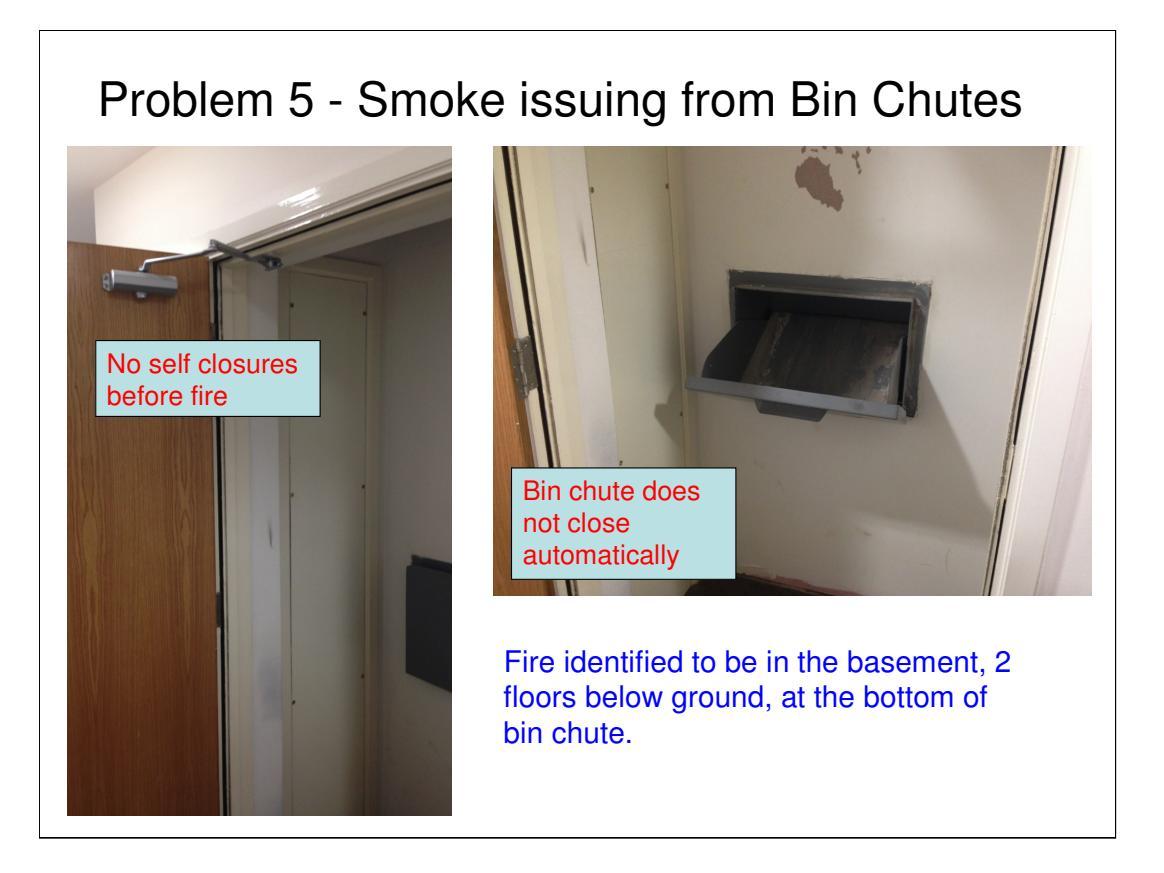
Next Slide: Problem 4 - Smoke Issuing from Bin Chutes

Smoke issuing from Bin Chutes on upper floors

No self closures on doors

Bin chute hatches do not close automatically

Doors left open by residents

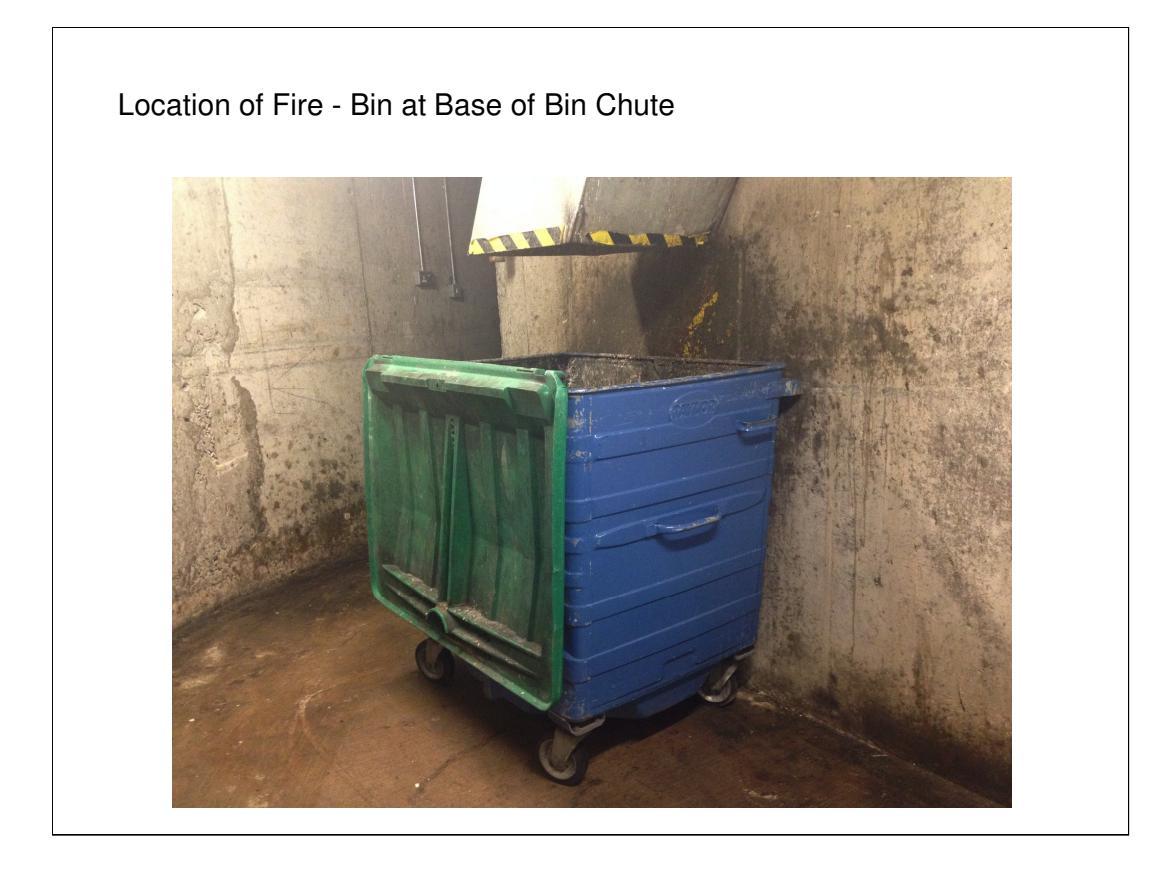
Next Slide: Location of Fire - Industrial Bin at bottom of Bin Chute

2 Floors Below Ground Level

Bin Chute is a vertical shaft that goes up 27 Floors

A bottle put into the bin shoot from upper floors travels so fast that when it hits this bin it is turned into dust!

Bin Chute often blocks when residents stuff large items into chute
