# **Learning from the Kiss Nightclub Fire**

**Karen Boyce**

## Overview

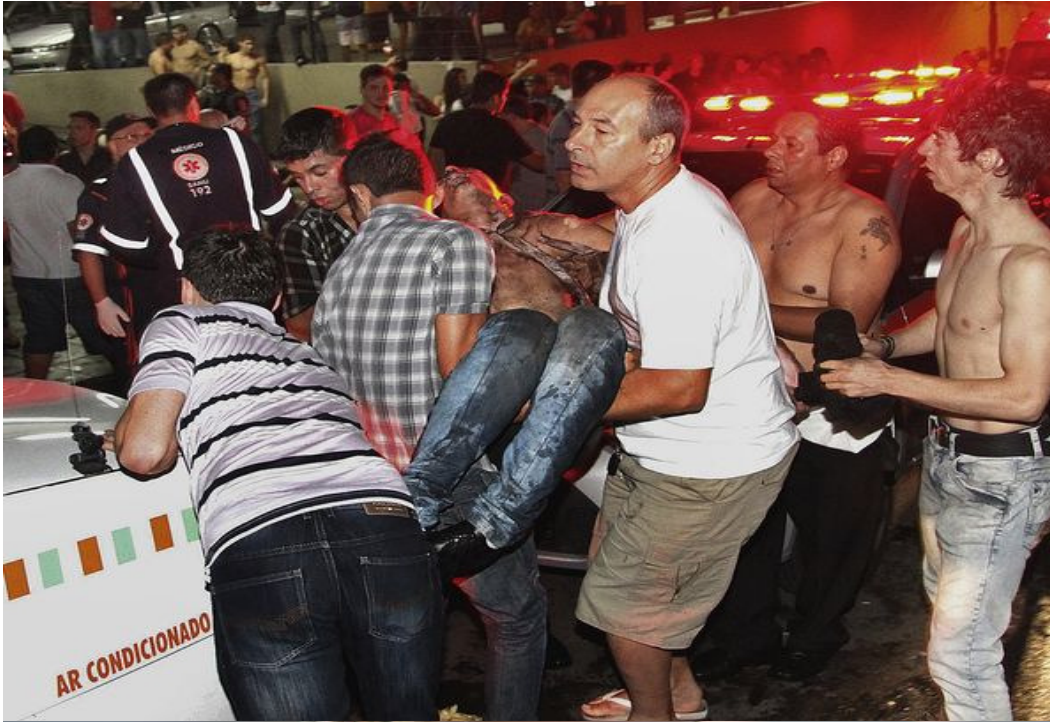
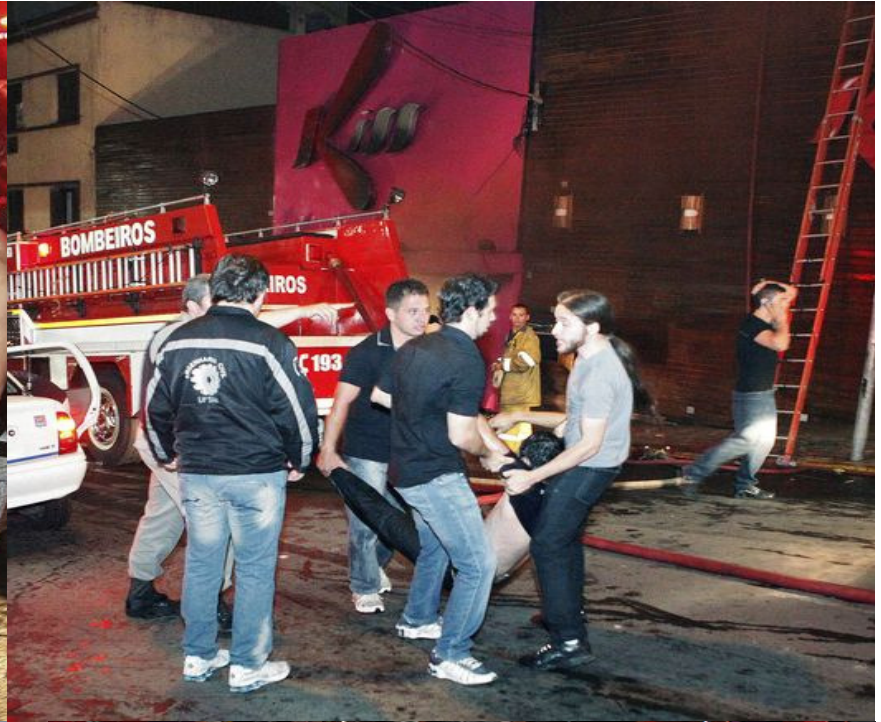
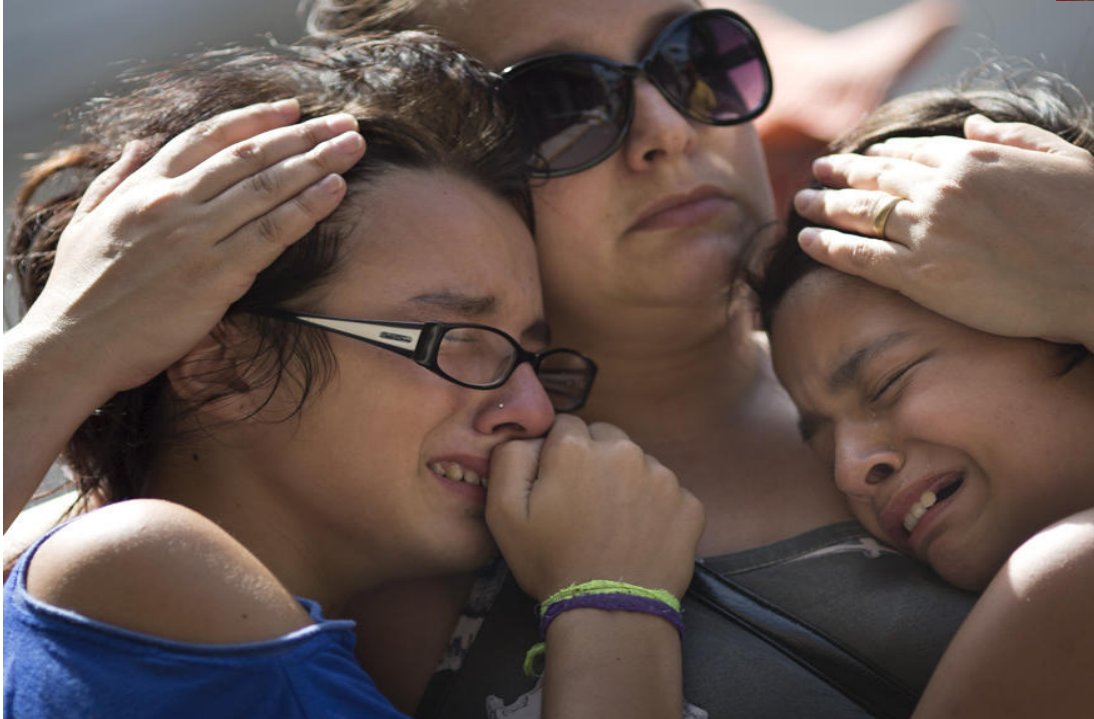
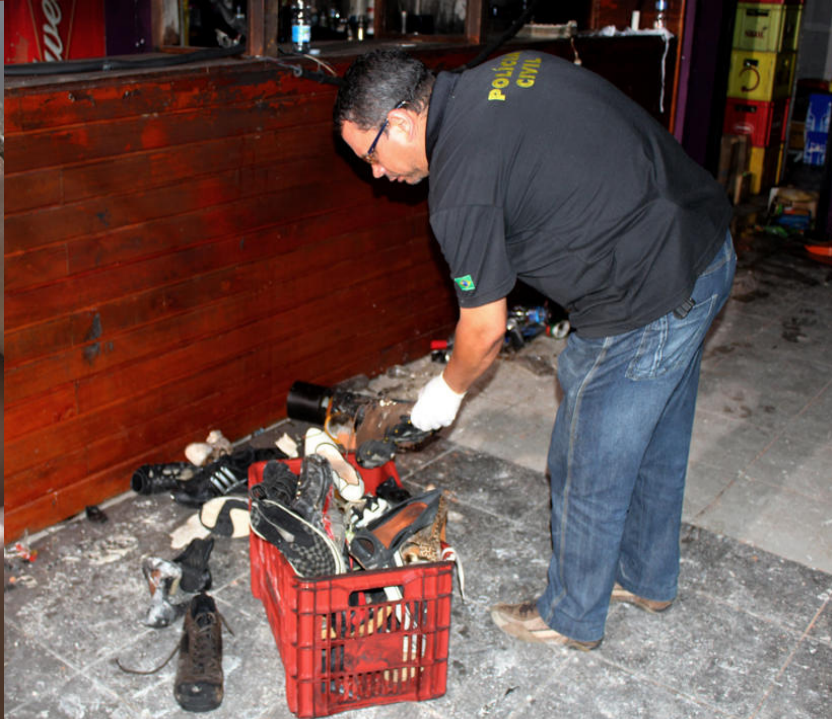
- Band lit sputnik on stage which ignited flammable sound proofing foam on ceiling
- Flare was cheap (\$1.25?) and can reach 4m (Brazilian Association of Pyrotechnics) - not to be used in closed environments
- Band originally claimed that they hadn't used sputnik but rather fire caused by electrical short circuit – disproved
- Ignited flammable sound-proofing on ceiling

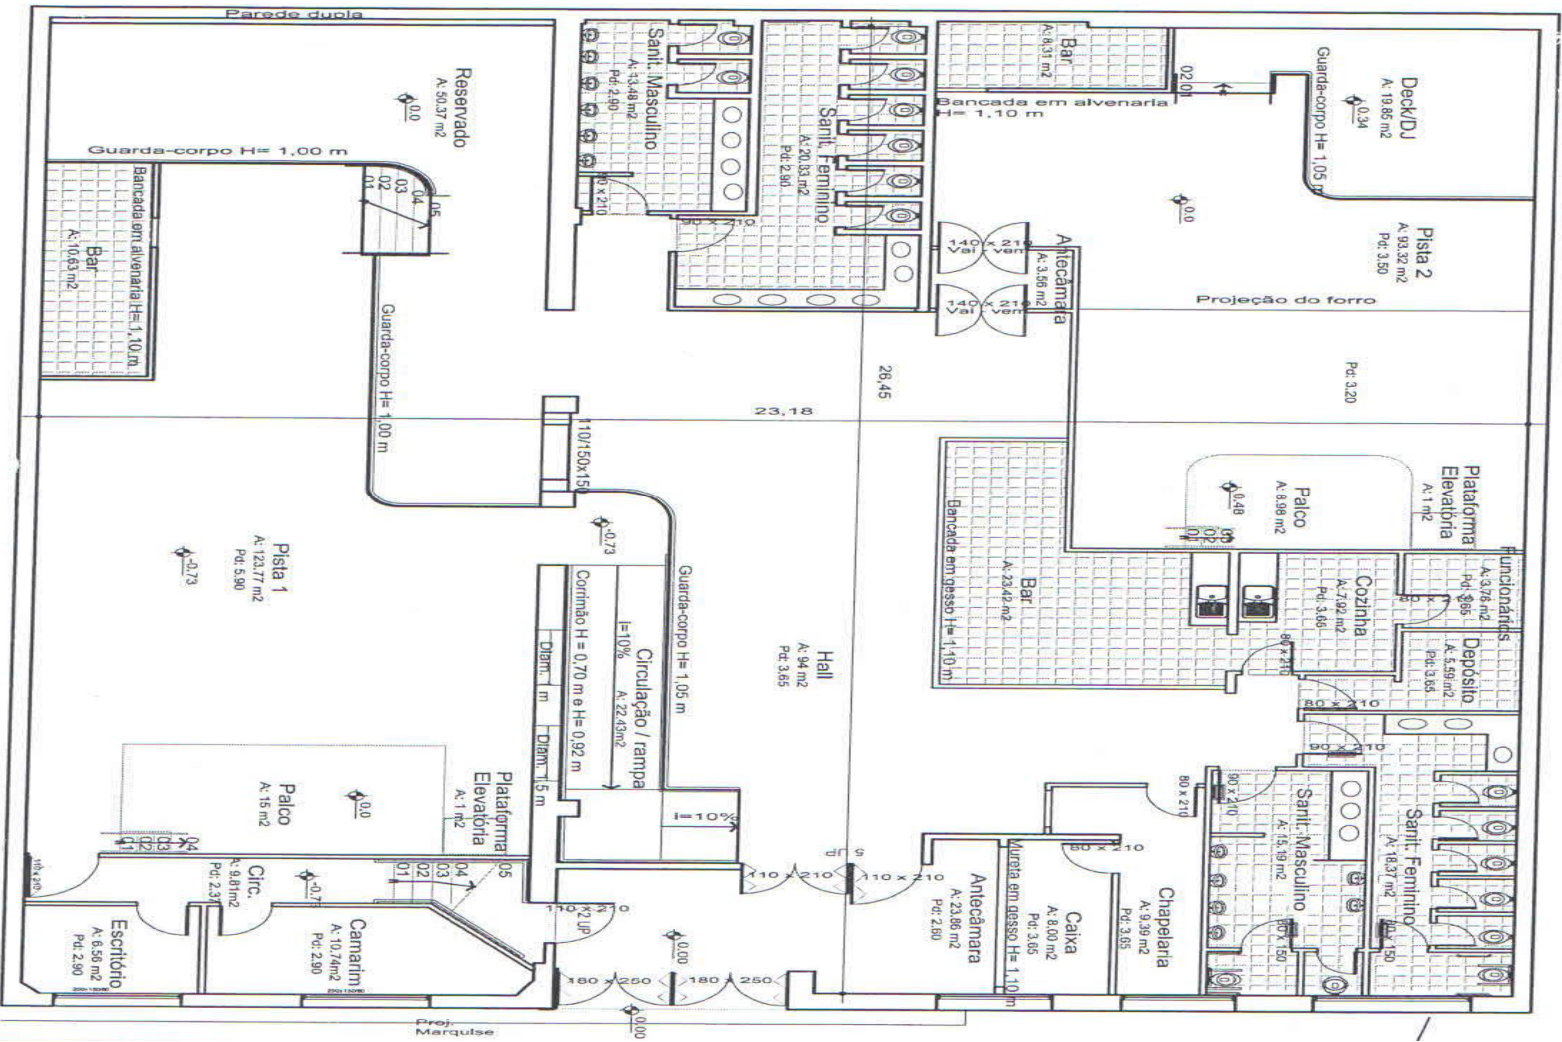
F. Anta Baixa  
Escala 1/125

- February 2012 – refurbishment of the stage, ticket office, built dressing room, mezzanine, and VIP area also with mezzanine
- November 2012, put in suspended ceiling (1.5 m below original) with flammable acoustic lining
- Demolished internal walls
- All without permission or without informing authorities

Danceteria  
A: 638,25 m²

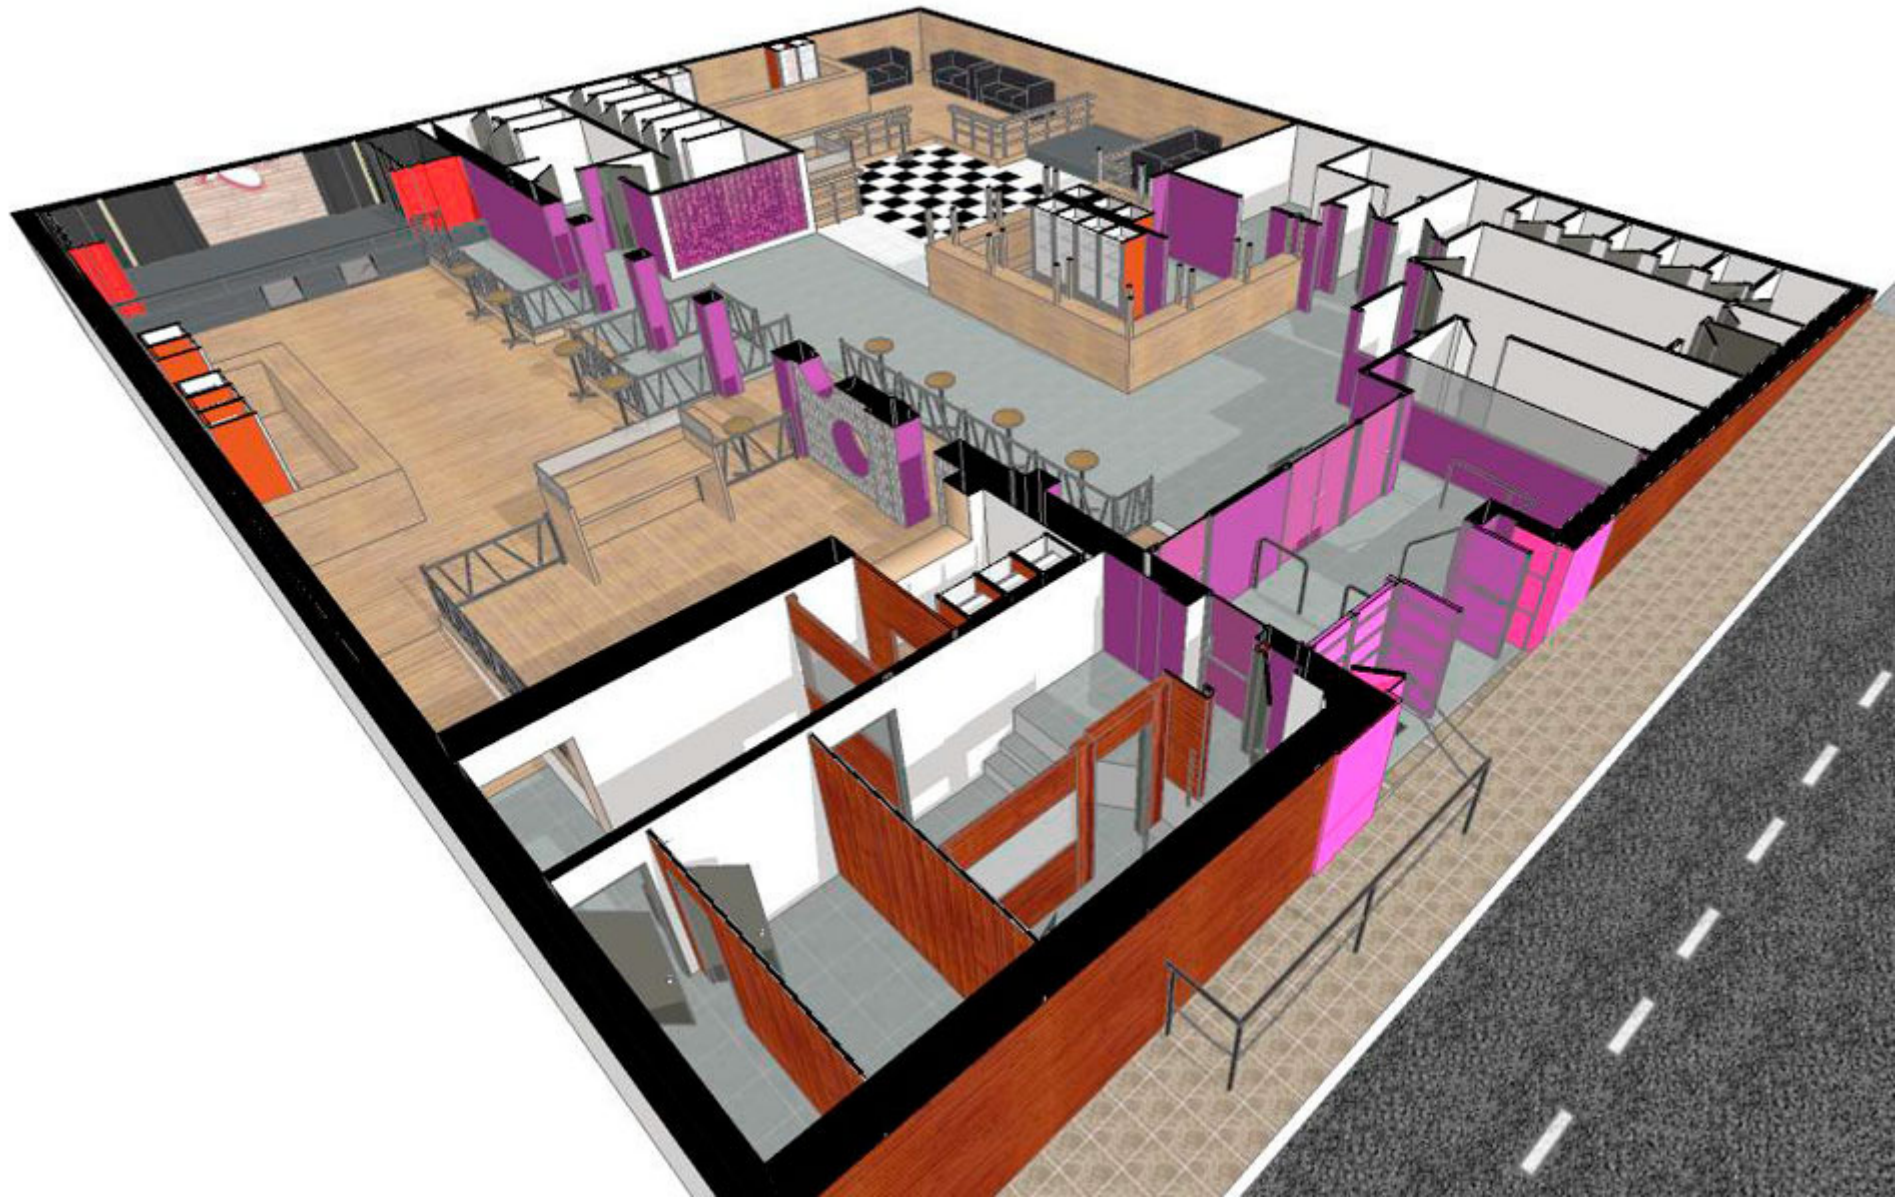
- At minimum a manual detection and alarm system  
(it had none)
- Emergency lighting (had but didn't work)
- 12 fire extinguishers (had 7 and at least one didn't work)
- Did not require or have sprinklers or smoke control

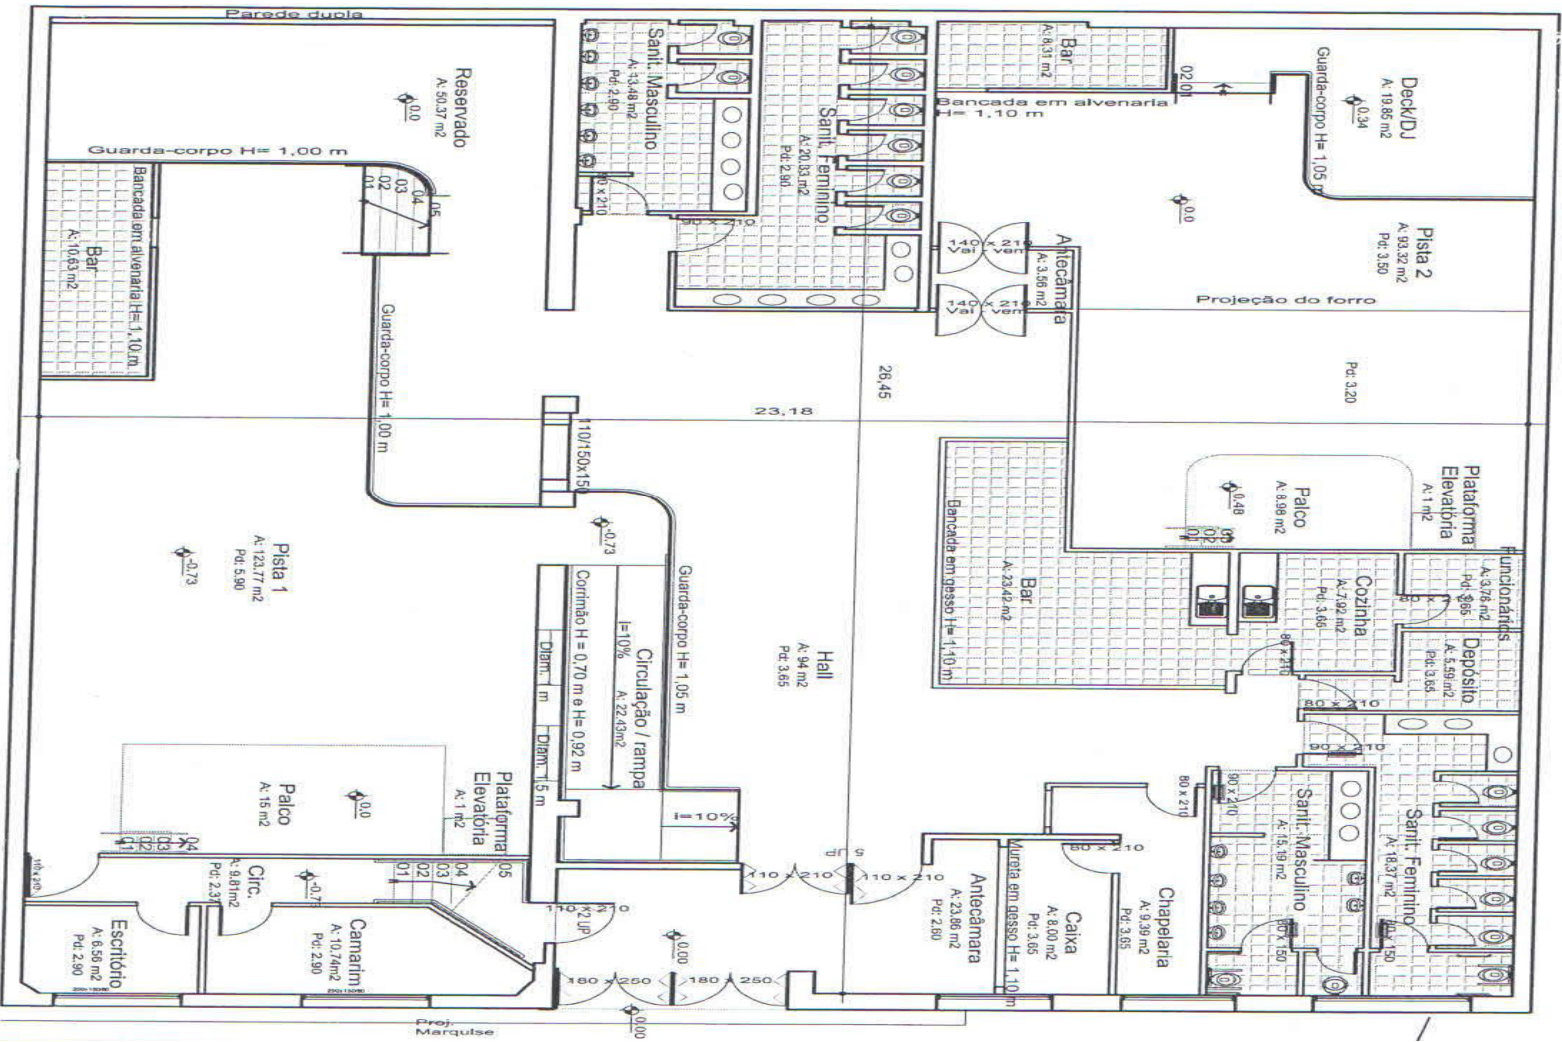
F. Anta Baixa  
Escala 1/125

- Number of exits depends on occupancy and size of building ( $>$  or  $<$  750 m<sup>2</sup>), no requirements for remoteness – this building required 2 exits (it had 2 exits from space which merged at 1 final exit)
- Exit sizing based on unit width/100 people (5.5 mm/person) ie 3.8 m (plans suggest 2 x 1.8m (front entrance) but other sources suggest 2 x 0.8m and pictures?)
- Travel distance depends on 1 or more exits and sprinkler/no sprinkler) – in this case 40m (max travel distanced reported to be 32 m)

Danceteria  
A: 638,25 m<sup>2</sup>

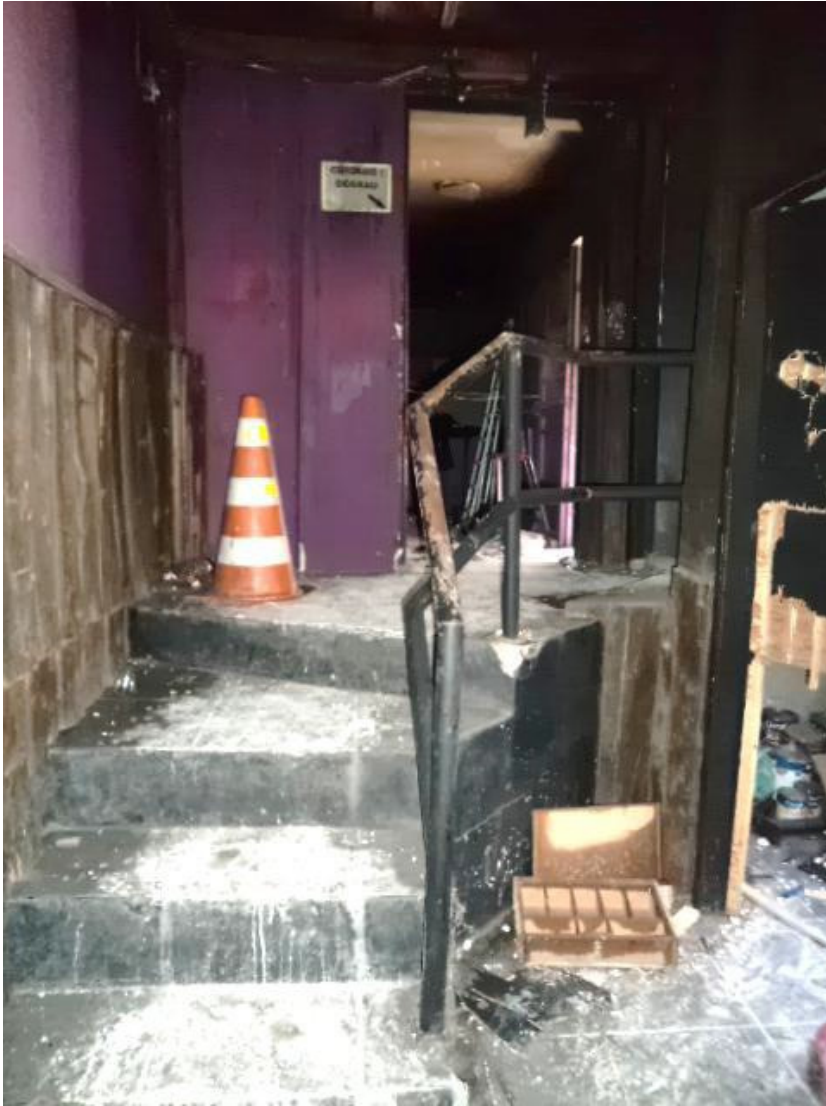
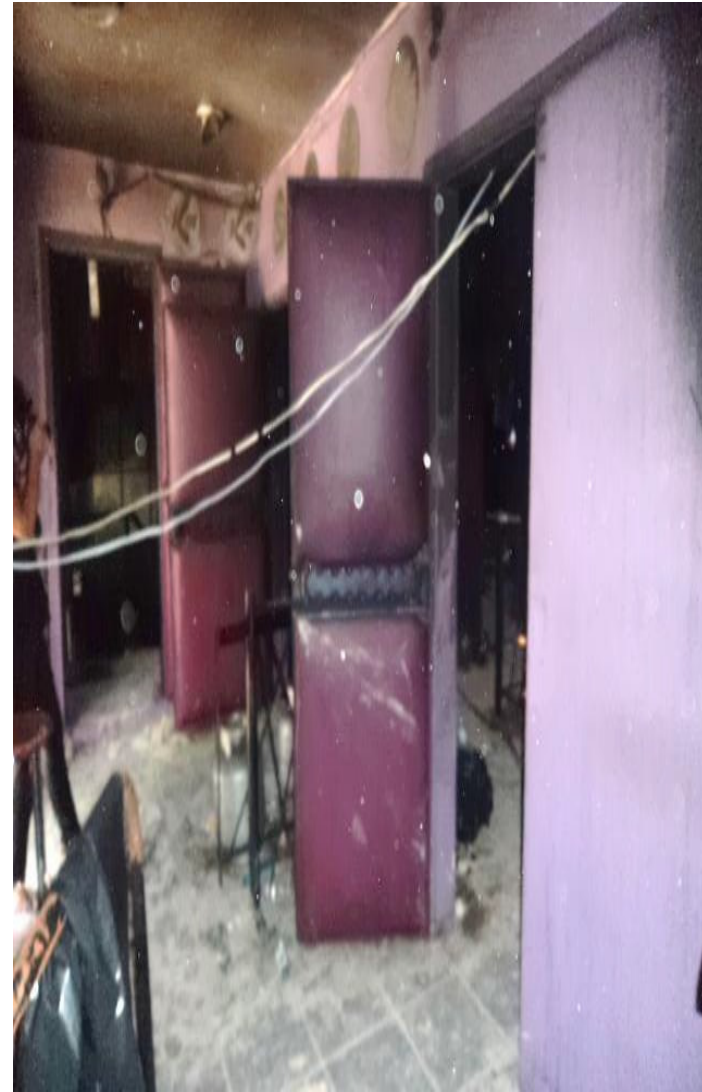
Exit corridor with stairs and 'foyer' at exit

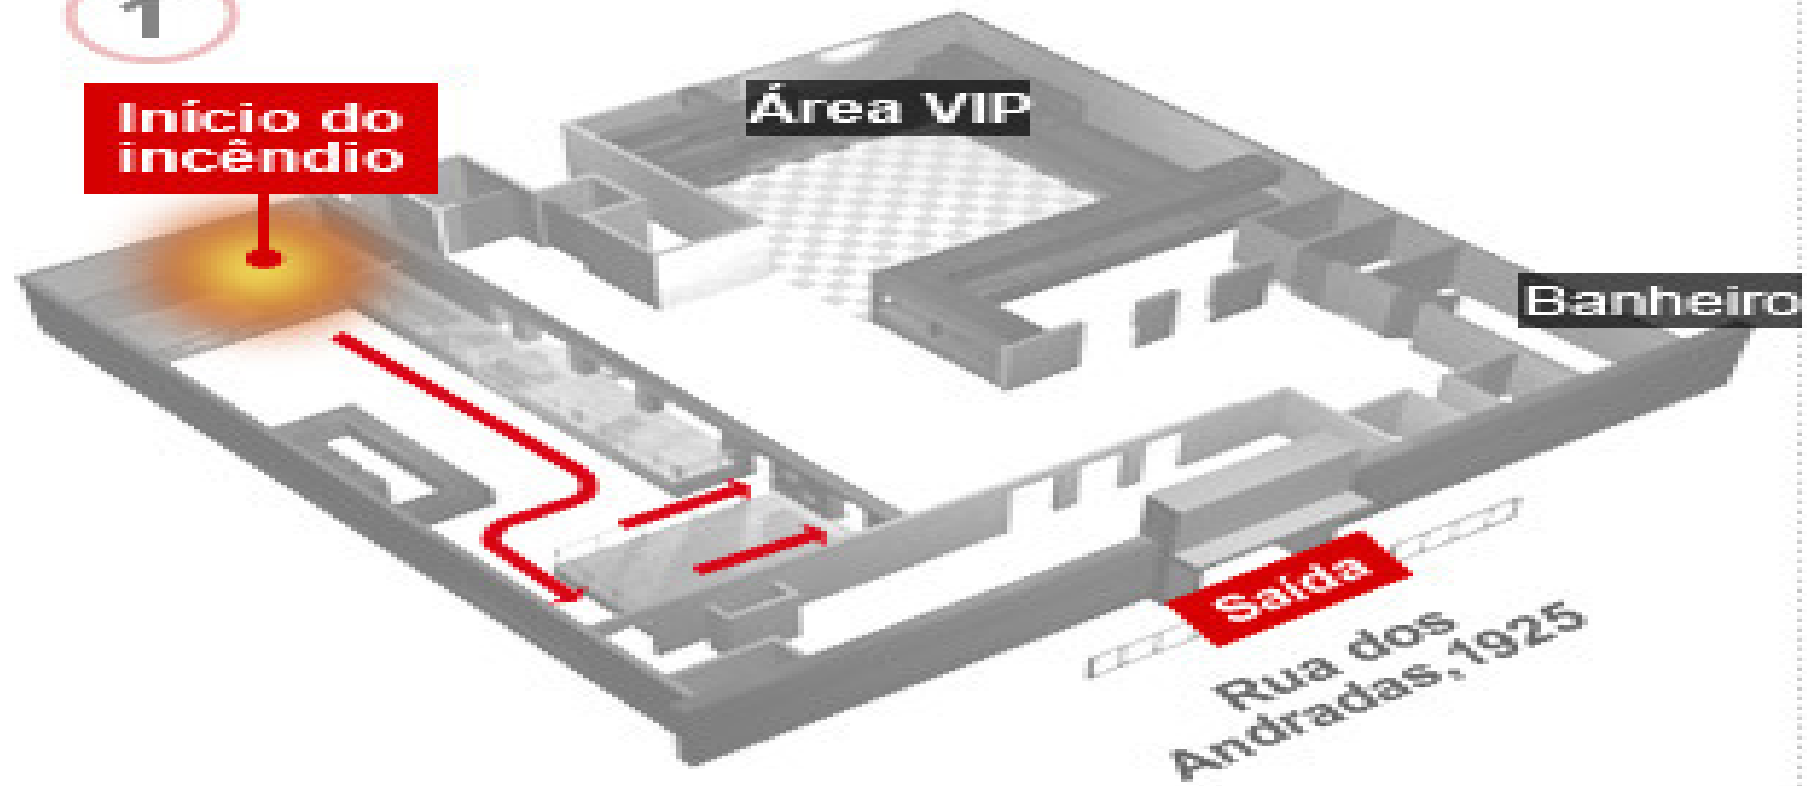
1

Logo que perceberam o fogo e a fumaça, as pessoas que estavam perto do palco começaram a correr procurando a saída para a rua

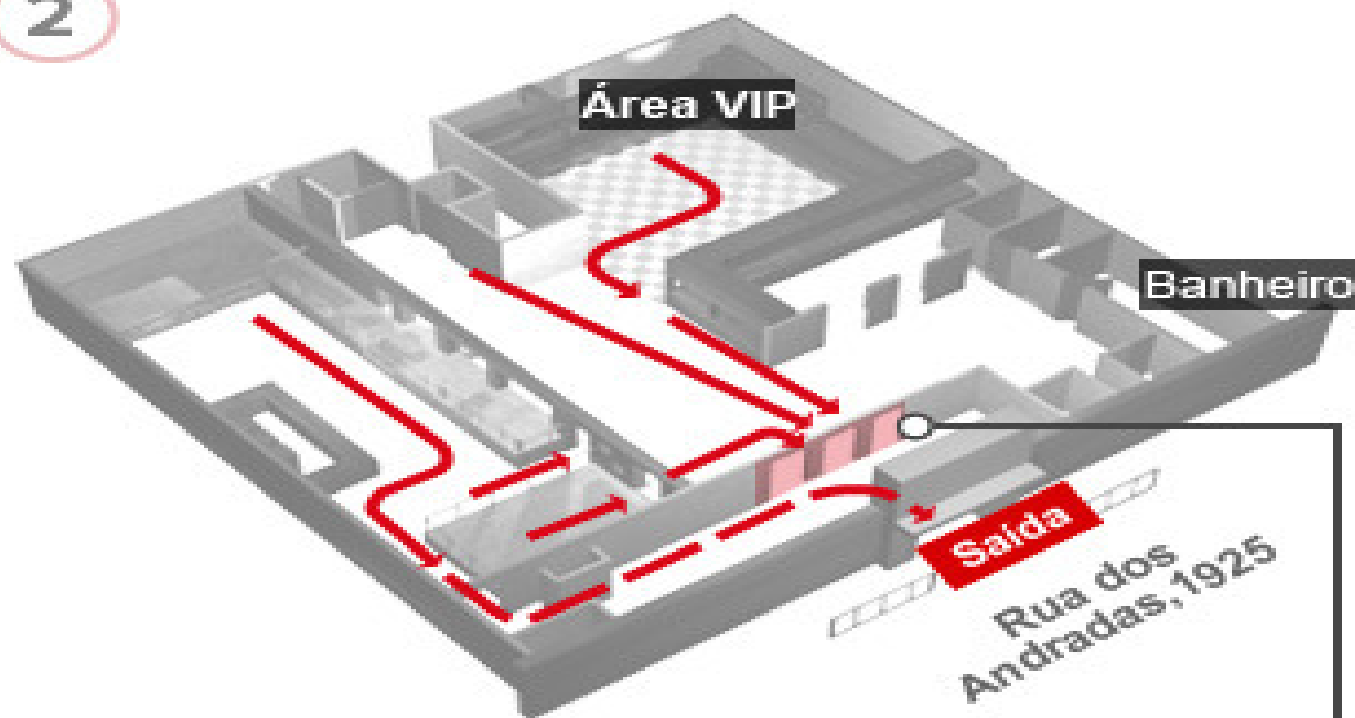
2

Quem estava na parte central da boate e na área VIP enfrentou, segundo testemunhas, a resistência de seguranças que num **primeiro momento barraram as pessoas** que não tinham a comanda paga

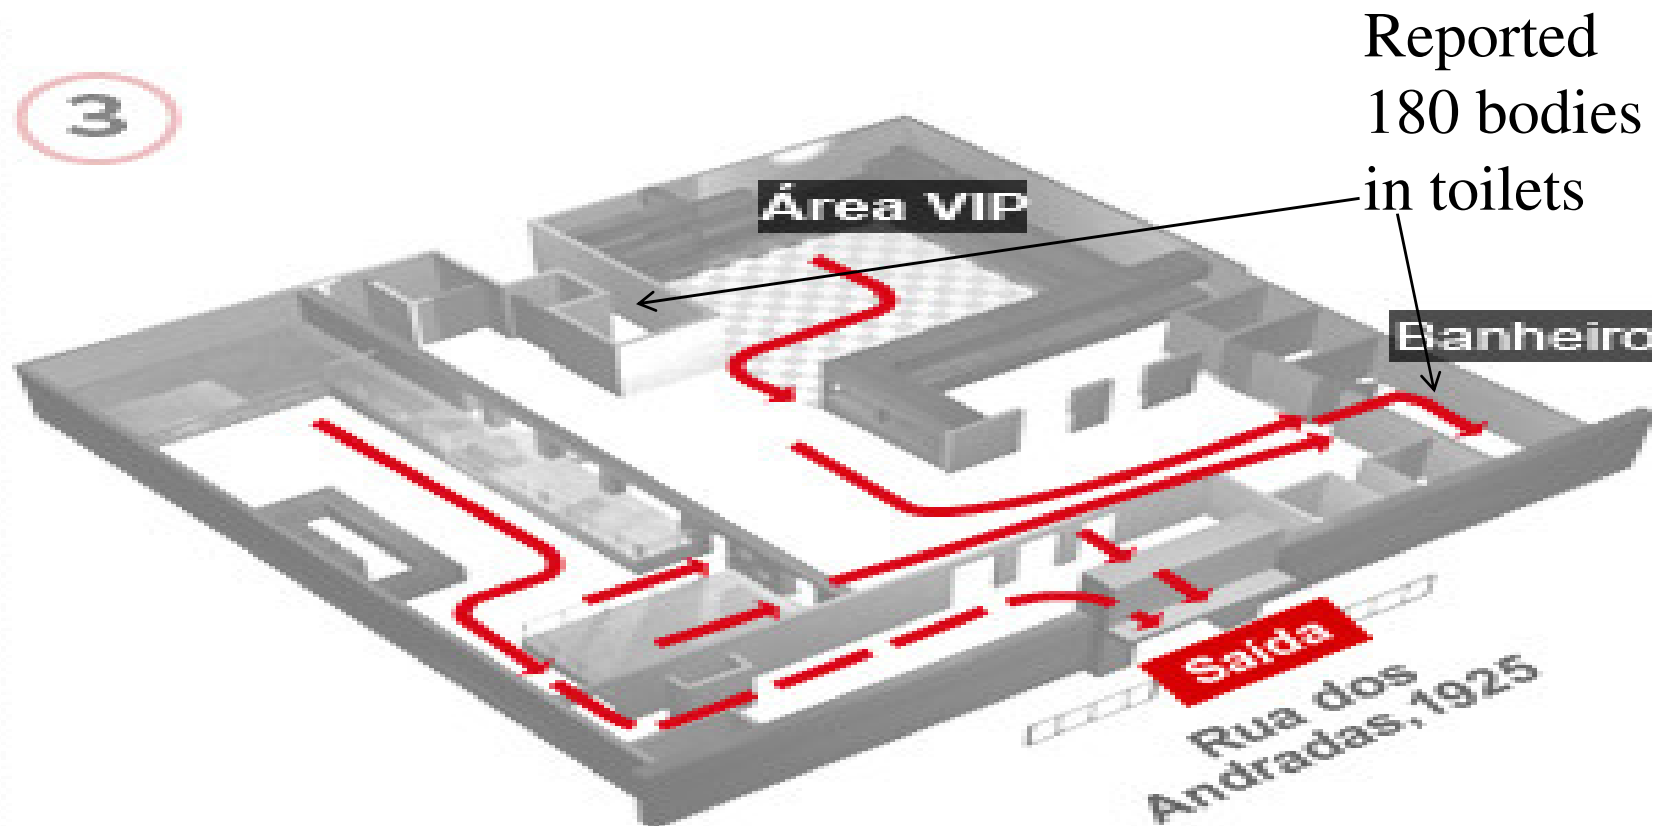
3

Em meio ao tumulto e devido ao ambiente escuro, muitos foram parar nos banheiros numa tentativa de escapar pelas janelas, mas o revestimento da fachada impediu que elas fossem abertas

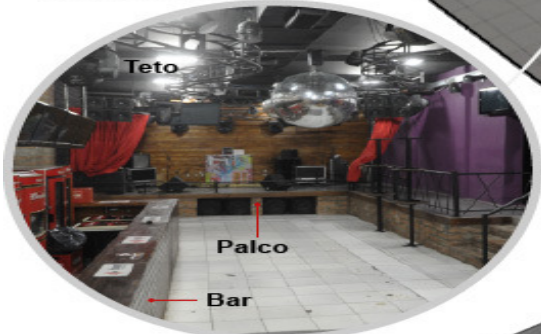
Pessoas começam a correr. Sem perceber de imediato o fogo, seguranças impedem a saída. Um 'biombo' trancava a porta de entrada/saída e atrapalha a evacuação. Grades no lado externo foi outro obstáculo

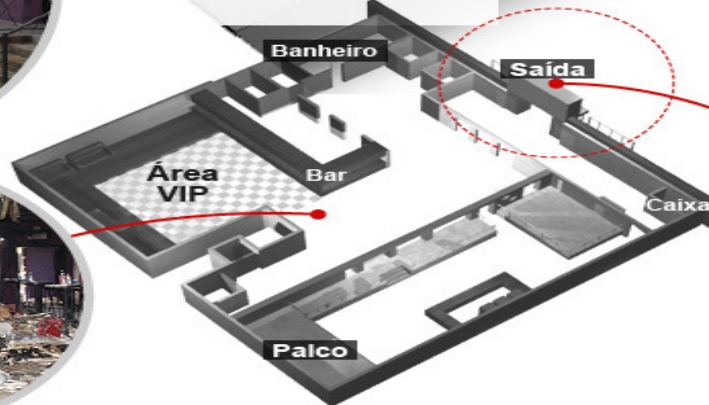
Devido à fumaça e ao ambiente escuro, público tem dificuldade para localizar a saída e muitos correm para os banheiros, por onde não conseguem escapar

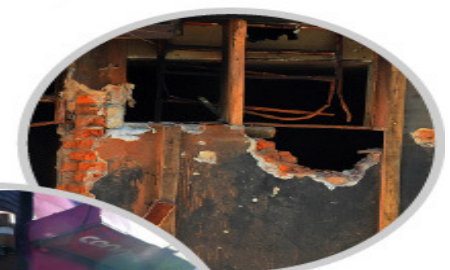
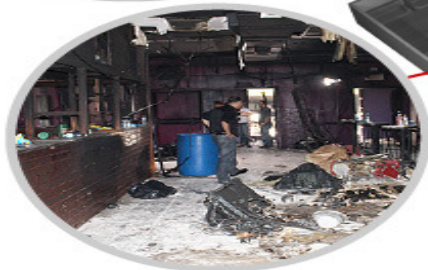
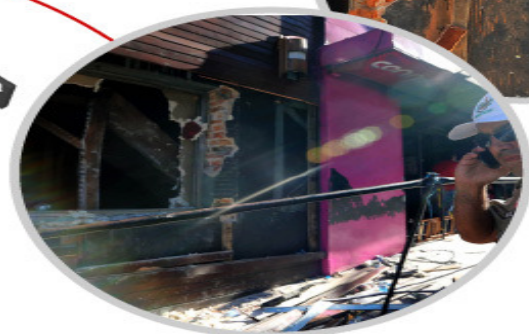
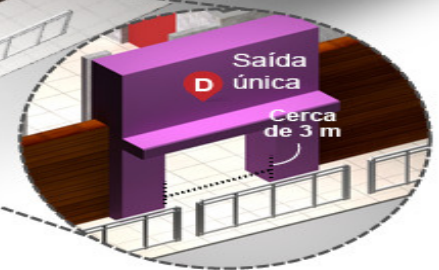
Sobreviventes tentaram tirar vítimas do local e quebraram as paredes da fachada. No banheiro, havia centenas de pessoas asfixiadas

Saída única

Cerca de 3 m
