Group Commander Kevin O'Neill

Community Development Dept

Harrow Court, Stevenage February 2005

Shirley Towers, Southampton, April

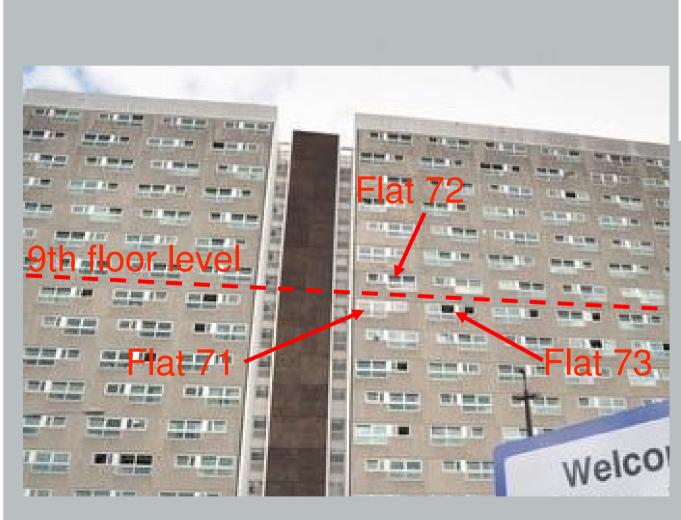
Location of Flat 72 (ninth floor) within Shirley Towers (only up flats shown)

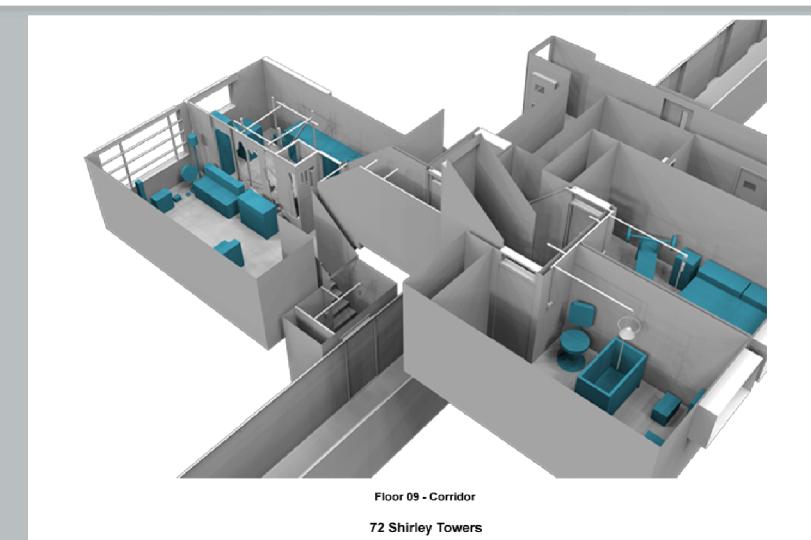
Plan of Flat 72, Shirley Towers.

Note:
Access to
lobby is on
the ninth
floor with
the fire exit
emergency
door
exiting on
the
eleventh
floor.
